## Failures in Aviation - Lessons for Healthcare

On the afternoon of 18 January 2023, a Boeing 737-838 aircraft, registered VH-XZB and operated by Qantas, departed Auckland, New Zealand on a scheduled passenger service to Sydney, Australia. While in the cruise, about 1 hour and 24 minutes after departure, there was an uncommanded shutdown of the left engine. Due to their location at the time, the flight crew declared a MAYDAY, to prioritise communications with air traffic control and to ensure they were cleared for an immediate descent to flight level 240 (24,000 ft). The engine could not be restarted in-flight, and the flight crew conducted an uneventful single-engine landing at Sydney Airport about 1 hour later.

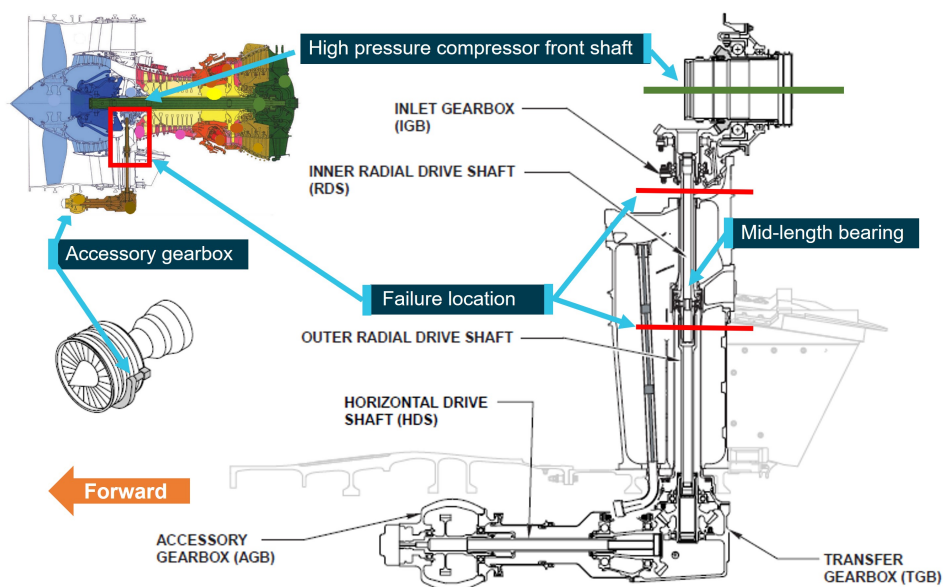
Figure 2: CFM56-7B engine, showing the accessory gearbox location, associated driveshafts and failure locations (red line)

An engine teardown inspection was conducted by the engine manufacturer at their technical facility in Malaysia and was observed by Qantas and the Air Accident Investigation Bureau Malaysia (on behalf of the ATSB). The examination identified that the inner radial driveshaft separated at 2 locations, at the mid-length bearing and near the upper spline (Figure 2). Subsequently, the mechanical discontinuity between the HPC shaft and accessory gearbox resulted in loss of fuel pump pressure and uncommanded shutdown of the engine. The mid-length bearing oil feed nozzle appeared clear (nil blockage). There was secondary damage to some components as the engine spooled down.

The failed driveshaft also prevented the starter from driving the HPC, which prevented the in-flight engine restart. [12]

The manufacturer advised that the level of deterioration of the failed driveshaft and mid-length bearing prevented identification of the separation initiator. Further, the inner driveshaft oil supply features were destroyed by the bearing failure and therefore its condition at the time of the event could not be determined. Nevertheless, the engine manufacturer reported that the rupture of the inner driveshaft was considered the primary failure.
