Failures in Aviation - Lessons for Healthcare

On the afternoon of 18 January 2023, a Boeing 737-838 aircraft, registered VH-XZB and operated by Qantas, departed Auckland, New Zealand on a scheduled passenger service to Sydney, Australia. While in the cruise, about 1 hour and 24 minutes after departure, there was an uncommanded shutdown of the left engine. Due to their location at the time, the flight crew declared a MAYDAY, to prioritise communications with air traffic control and to ensure they were cleared for an immediate descent to flight level 240 (24,000 ft). The engine could not be restarted in-flight, and the flight crew conducted an uneventful single-engine landing at Sydney Airport about 1 hour later.

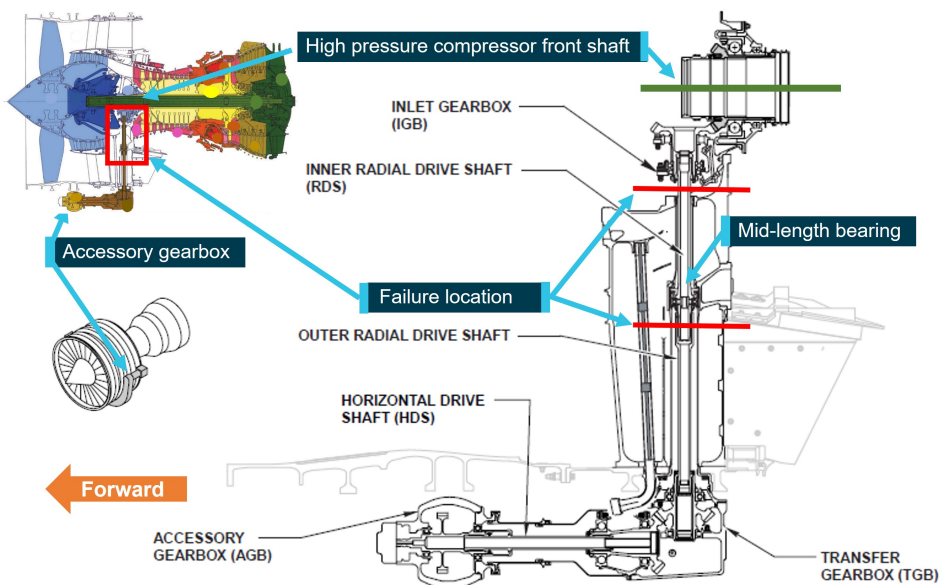
Figure 2: CFM56-7B engine, showing the accessory gearbox location, associated driveshafts and failure locations (red line)

An engine teardown inspection was conducted by the engine manufacturer at their technical facility in Malaysia and was observed by Qantas and the Air Accident Investigation Bureau Malaysia (on behalf of the ATSB). The examination identified that the inner radial driveshaft separated at 2 locations, at the mid-length bearing and near the upper spline (Figure 2). Subsequently, the mechanical discontinuity between the HPC shaft and accessory gearbox resulted in loss of fuel pump pressure and uncommanded shutdown of the engine. The mid-length bearing oil feed nozzle appeared clear (nil blockage). There was secondary damage to some components as the engine spooled down.

The failed driveshaft also prevented the starter from driving the HPC, which prevented the in-flight engine restart. [12]

The manufacturer advised that the level of deterioration of the failed driveshaft and mid-length bearing prevented identification of the separation initiator. Further, the inner driveshaft oil supply features were destroyed by the bearing failure and therefore its condition at the time of the event could not be determined. Nevertheless, the engine manufacturer reported that the rupture of the inner driveshaft was considered the primary failure.

- During cruise, separation of the radial driveshaft led to a mechanical discontinuity between the engine core and accessory gearbox. This resulted in loss of the accessory gearbox-driven main fuel pump pressure and uncommanded shutdown of the left engine. In addition, the failed driveshaft prevented the engine from being restarted in-flight.
