## Failures in Aviation - Lessons for Healthcare

On the afternoon of 18 January 2023, a Boeing 737-838 aircraft, registered VH-XZB and operated by Qantas, departed Auckland, New Zealand on a scheduled passenger service to Sydney, Australia. While in the cruise, about 1 hour and 24 minutes after departure, there was an uncommanded shutdown of the left engine. Due to their location at the time, the flight crew declared a MAYDAY, to prioritise communications with air traffic control and to ensure they were cleared for an immediate descent to flight level 240 (24,000 ft). The engine could not be restarted in-flight, and the flight crew conducted an uneventful single-engine landing at Sydney Airport about 1 hour later.

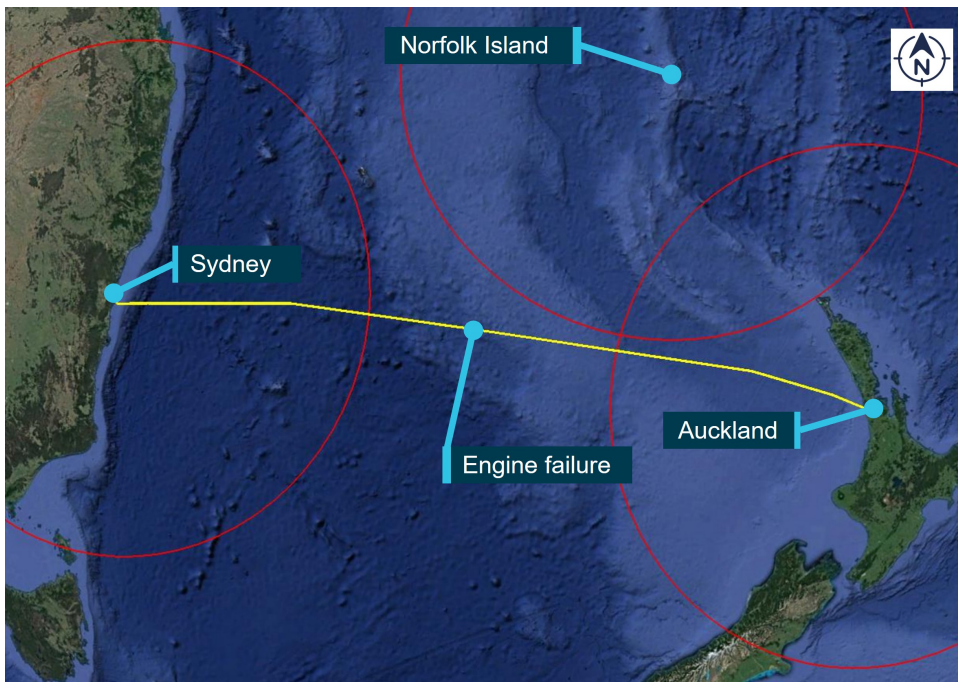
**Figure 3: Engine failure location with respect to the 400 NM (741 km) EDTO radius from nearby alternate airports**

At the time of the engine failure, the aircraft was located about (distance from) (Figure 3):

- Auckland 611 NM (1,132 km) and a 180° turn
- Sydney 560 NM (1,037 km) continuing on the current track
- Williamtown/Newcastle 550 NM (1,019 km) with a slight diversion to right of track
- Norfolk Island 484 NM (896 km) and a 115° right turn.
