Failures in Aviation - Lessons for Healthcare

On the afternoon of 18 January 2023, a Boeing 737-838 aircraft, registered VH-XZB and operated by Qantas, departed Auckland, New Zealand on a scheduled passenger service to Sydney, Australia. While in the cruise, about 1 hour and 24 minutes after departure, there was an uncommanded shutdown of the left engine. Due to their location at the time, the flight crew declared a MAYDAY, to prioritise communications with air traffic control and to ensure they were cleared for an immediate descent to flight level 240 (24,000 ft). The engine could not be restarted in-flight, and the flight crew conducted an uneventful single-engine landing at Sydney Airport about 1 hour later.

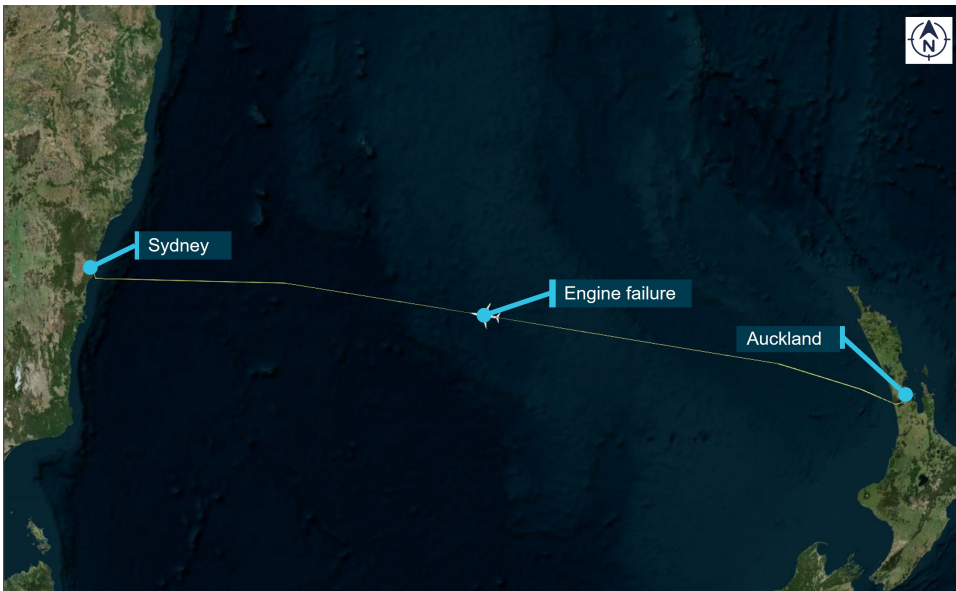
Figure 1: Map showing VH-XZB flight path and location of the engine failure

After about 1 hour in the cruise, the flight crew transferred high frequency (HF) radio communications from Auckland to the en route controller at Brisbane Centre (en route controller).^[5] Once the en route controller accepted monitoring of the aircraft, the flight crew requested to climb to FL 380. About 3 minutes later, and before the climb was authorised, the flight crew reported hearing a 'pop' sound, followed by the autopilot and auto throttle disengaging, with associated warning lights and horn. They then identified left (#1) engine was not operating. The flight crew broadcast MAYDAY,^[6] citing an engine failure and requested an immediate descent to FL 240. The en route controller enquired if it was a single or double engine failure, to which the flight crew confirmed a single-engine failure (Figure 1). About 1 minute later, the en route controller authorised a descent to FL 240 when ready.

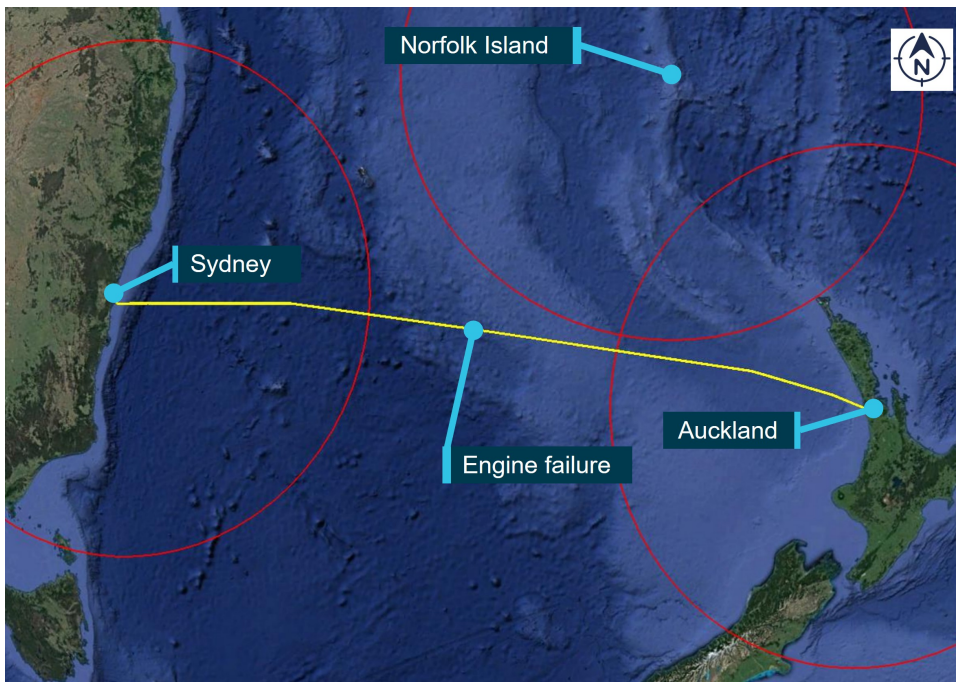
Figure 3: Engine failure location with respect to the 400 NM (741 km) EDTO radius from nearby alternate airports

At the time of the engine failure, the aircraft was located about (distance from) (Figure 3):

- Auckland 611 NM (1,132 km) and a 180° turn
- Sydney 560 NM (1,037 km) continuing on the current track
- Williamtown/Newcastle 550 NM (1,019 km) with a slight diversion to right of track
- Norfolk Island 484 NM (896 km) and a 115° right turn.
