Failures in Aviation - Lessons for Healthcare

REAL CASE EXAMPLE

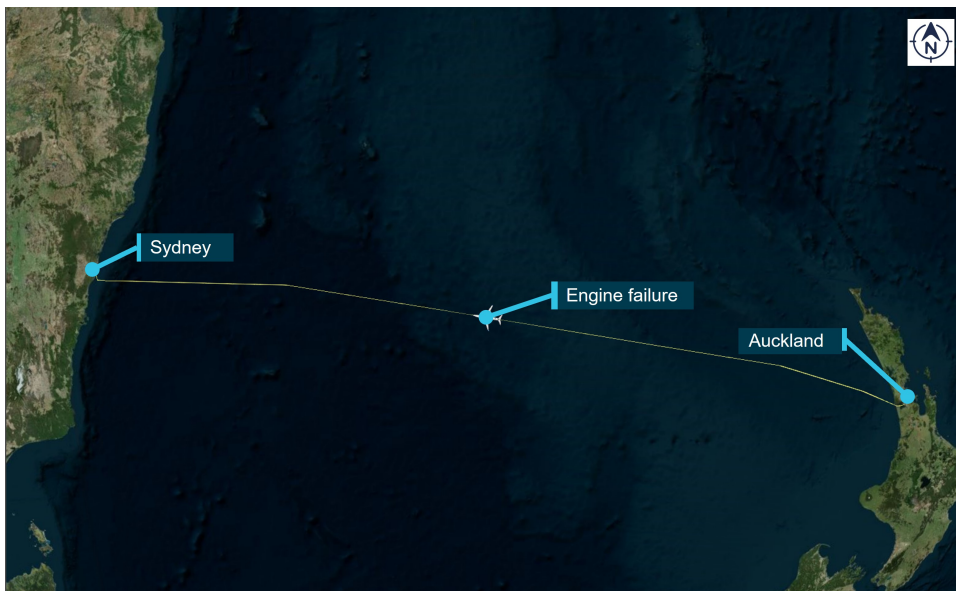
Figure 1: Map showing VH-XZB flight path and location of the engine failure

Source: APS Flight Analysis System (FAS) using Cesium, annotated by the ATSB

After about 1 hour in the cruise, the flight crew transferred high frequency (HF) radio communications from Auckland to the en route controller at Brisbane Centre (en route controller).^[5] Once the en route controller accepted monitoring of the aircraft, the flight crew requested to climb to FL 380. About 3 minutes later, and before the climb was authorised, the flight crew reported hearing a 'pop' sound, followed by the autopilot and auto throttle disengaging, with associated warning lights and horn. They then identified left (#1) engine was not operating. The flight crew broadcast MAYDAY.^[6] citing an engine failure and requested an immediate descent to FL 240. The en route controller enquired if it was a single or double engine failure, to which the flight crew confirmed a single-engine failure (Figure 1). About 1 minute later, the en route controller authorised a descent to FL 240 when ready.
